Practice of Concrete Production in Gaidakot Municipality, Nepal

The paper aims to assess the practice and perception of people during concreting of the residential building at study sites of Gaindakot Municipality, Nepal.

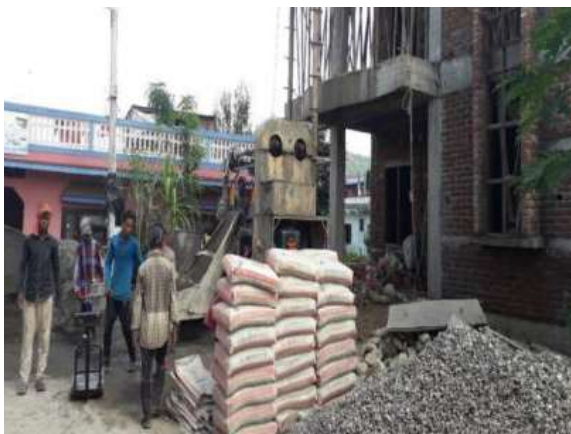
Figure 10. Stacking of Cement

In all sites, the cement was found to be purchased on the day of concreting for a structural component. Time was scheduled however resources were not levelled or scheduled at those sites. Besides the cement required for other purposes like wall construction and plaster was found to stack on the shed of Brick with CGI sheet with plastic for damp proofing (Figure 10).

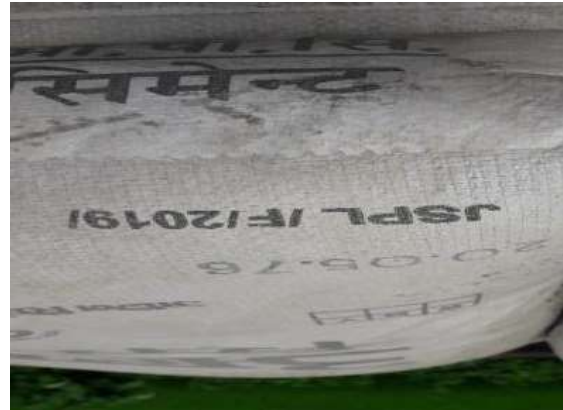
Figure 11. Cement Bags without clear manufacturing date

In all sites, neither house owner nor contractor was aware of the age of cement i.e., the duration of between cement manufactured and used the manufactured date was not indicated on cement bags used in construction sites (Figure 11).

As per Bureau of Indian Standard (2000), the manufacturer should print the manufacture date in cement sacks. Also, the consumers were promoted to use fresh cement. But in field visit, the manufacture date in the cement sacks was found to be missing whereas though the manufactured date was found in, there was unclear information about the year and manufacture lot number. This unawareness was leading to use cement of old age i.e not fresh cement and it might be affecting the strength of concrete directly.

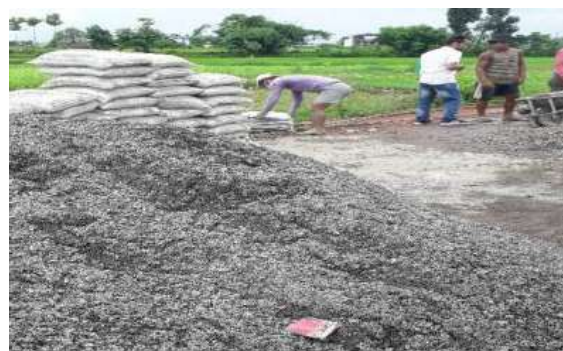
Figure 12. Impurities on Aggregate

Quality of ingredients was not taken into due care. The suppliers determine the material to provide to the sites. During concreting, the workmanship regarding quality was found to be poor (Figure 12).

As per Bureau of Indian Standard (1996), it was reported that the aggregates should be stored at the site on a hard dry and level patch of ground to prevent contamination with clay, dust, vegetable and other foreign matter. But in field visit, it was found the aggregates were stacked in the muddy ground too, without and preventive measures

for contamination. In the majority of sites, it was found that the aggregates were contaminated with vegetation, plastics and sacks etc. Similarly, the workers were found neglecting the removable foreign item too. It was a lack of proper guidance and their hurriedness to finish the work.

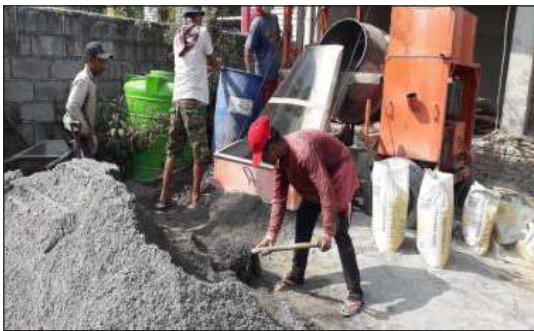
Figure 13. Worker feeding sand using shovel only

The ingredients were poured based on the assumption in some sites. The sand was feed in the mixer with the shovel only without using any measurement box, counting several shovels used. It reveals that the dosage of ingredients is not consistent and depends on the mood of the pourer (Figure 13).

In section 2, it was reported that there should be the accuracy of the instrument should be (+/-) 3% of quantity to be measured and should mix the ingredients measured with the instrument but in field visits, it was found that the workers were neglecting the accuracy in ingredients proportion. They were feeding ingredients in assumption basis to minimize the effort. No professionalism was found in workmanship due to lack of education and guidance.

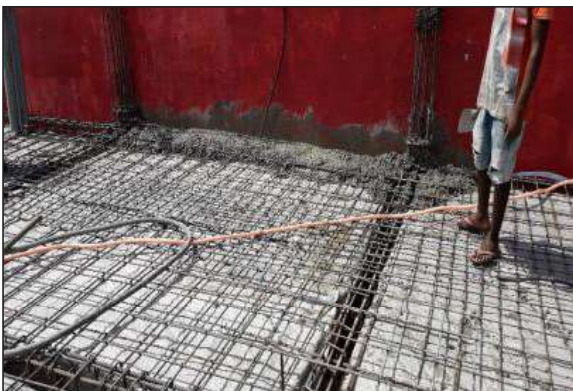
Figure 14. Concrete pouring segment wise in beam and slab portion

The placement of concrete was done in segment-wise. First beam portion was concreted with relatively low water content concrete and the slab portion was concreted with higher water content concrete for easy workability (Figure 14).

As reported in section 2, no precaution was taken while the placement of concrete. The placement was in hurry with the extra labour force, which was segregating the concrete. There was no continuum in the placement of concrete within the same structure. A serious problem was the remaining portion of concrete of each batch at the end, which was already set and creating a problem for replacement.

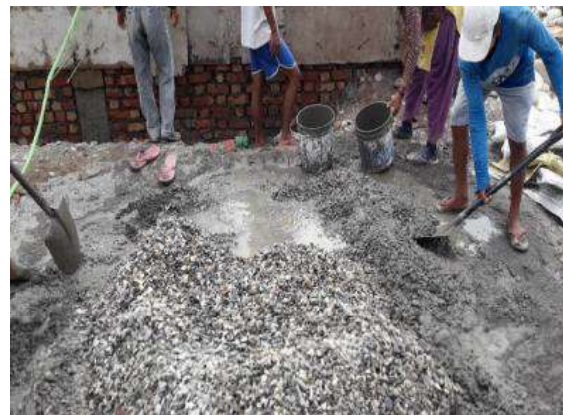
Figure 15. High water content for easy workability

During mixing for a structural component like column or tie beam, the concrete was mixed manually. The situation for the tie beam was disastrous as there was a high content of water for high workability. And the volume of concreting was high, with loading time more than the initial setting time of concrete. Similarly, concreting was done during raining too (Figure 15).

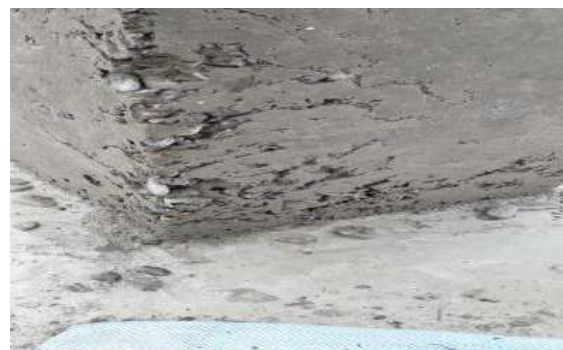
Figure 16. Improper compaction during concreting

Compaction is not proper, in slab most of the concrete was found to be segregated, and in the column, the concrete was found to be placed without proper compaction.

As reported in section 2, no proper curing method was found applying at the site. The concrete was highly vibrated and compacted in some places where easy, but neglected in corners and difficult portions. The base of the column was found improperly compacted in major sites, making them weak and of low strength (Figure 16).

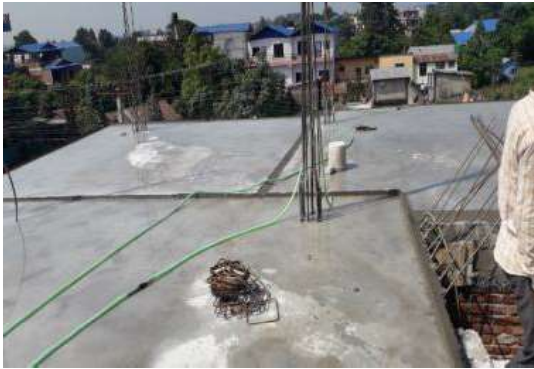
Figure 17. Work starting after 3rd day of concreting

Curing was not properly done. The curing for the column was done by spraying water twice or thrice a day. In slab only 4-5 days curing was done. Normally not more than 10 days was allowed for curing. In some cases, it was found that the work was started from the 3rd day of the casting of slab (Figure 17).

As reported in section 2, the concrete surface should be kept in moisture condition for at least 7 days, such practice was found on the majority of sites for only slabs. In some cases, a minimum of only 3 or 4 days was allowed for moistening with water. But mainly a week was allowed with water curing. This was a good practice found in concreting during a field visit. But in the case of columns, no adequate curing was found. Jute or sacks wrapping was never adopted in any construction practice by workers. The column is kept in moisture condition with spraying the water twice or thrice a day. It was also found that none of the concreting practitioners involves in the curing process. House owner solely is responsible and they were doing what they knew only.

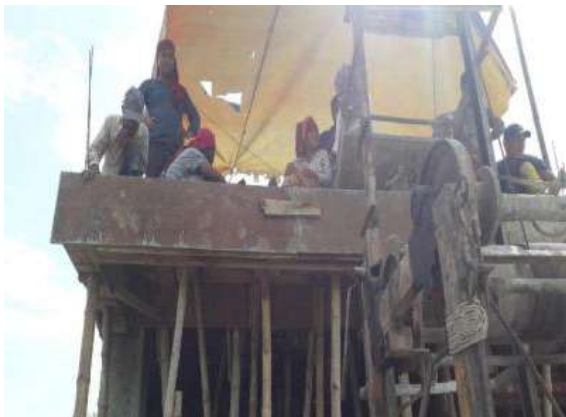
Figure 19. Use of Wooden props and wooden formwork

The form works were found to be consists of wooden planks and bamboo props in many sites. The formworks were found to be removed for slabs after 20 days of concreting (Figure 18).
